Locomotive 4561

**Progress since AGM 2016
and Future Locomotive Strategy**

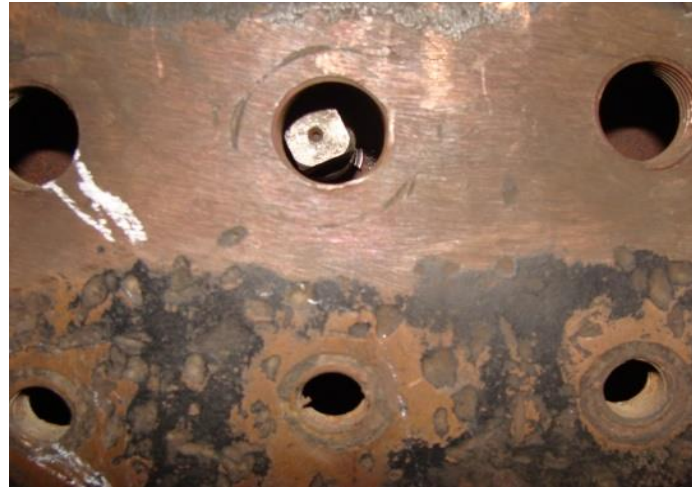
In the first picture you can see there is a slight mis-alignment between the firebox and the outer wrapper. The picture taken looking towards the throat plate.

- There are some dimensional concerns about the boiler that could effect both it's completion and longevity in service.
- We are in touch with the contractor over this matter and are seeking to agree a remedial work plan.
- We have undertaken significant metrology work at Williton to understand the problem.

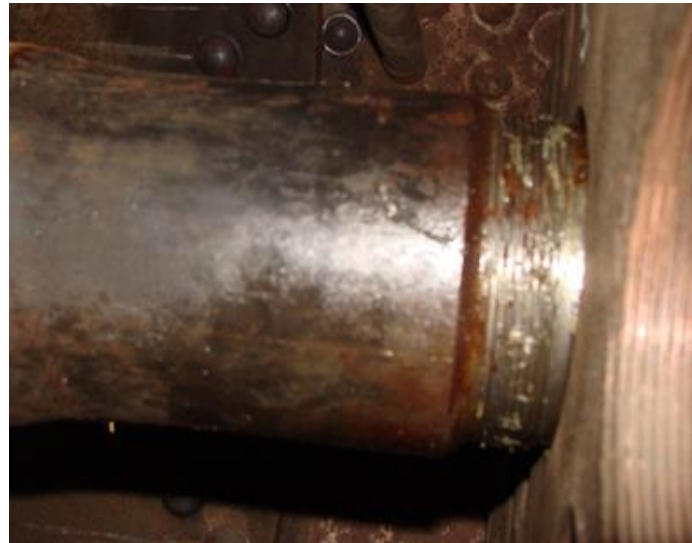
In this picture you can see the slight misalignment between a flue tube we offered up and the rear plate of the firebox.
